STUDY ON THE NATURAL-HAZARDS VULNERABILITY AND RISK PROFILES IN HOT-SPOT AREAS AS A SUPPORT TO EARLY WARNING, DISASTER PREPAREDNESS AND RISK REDUCTION (EWDPRR) MEASURES IN UGANDA.

Dr. Kitutu Kimono Mary Goretti

2013.

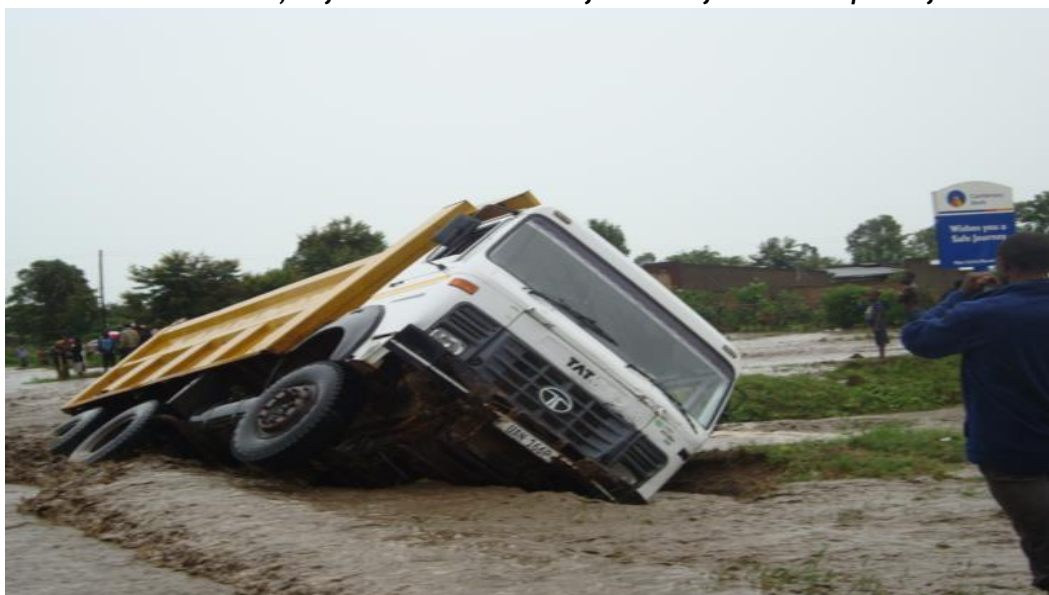
Plate 2.1. A truck swept by a flood and is stuck in the mud in Kasese town.

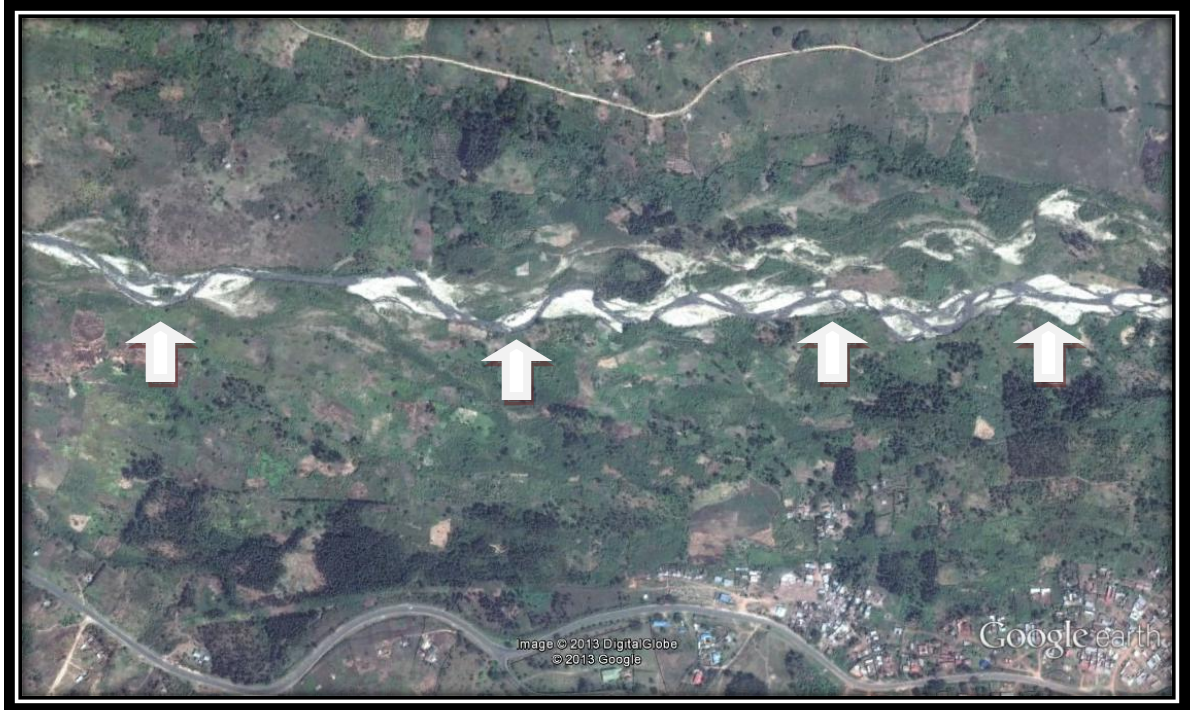
Figure 2.5. White arrows show some of the areas where water is diverted for irrigation. Source: Google Earth maps

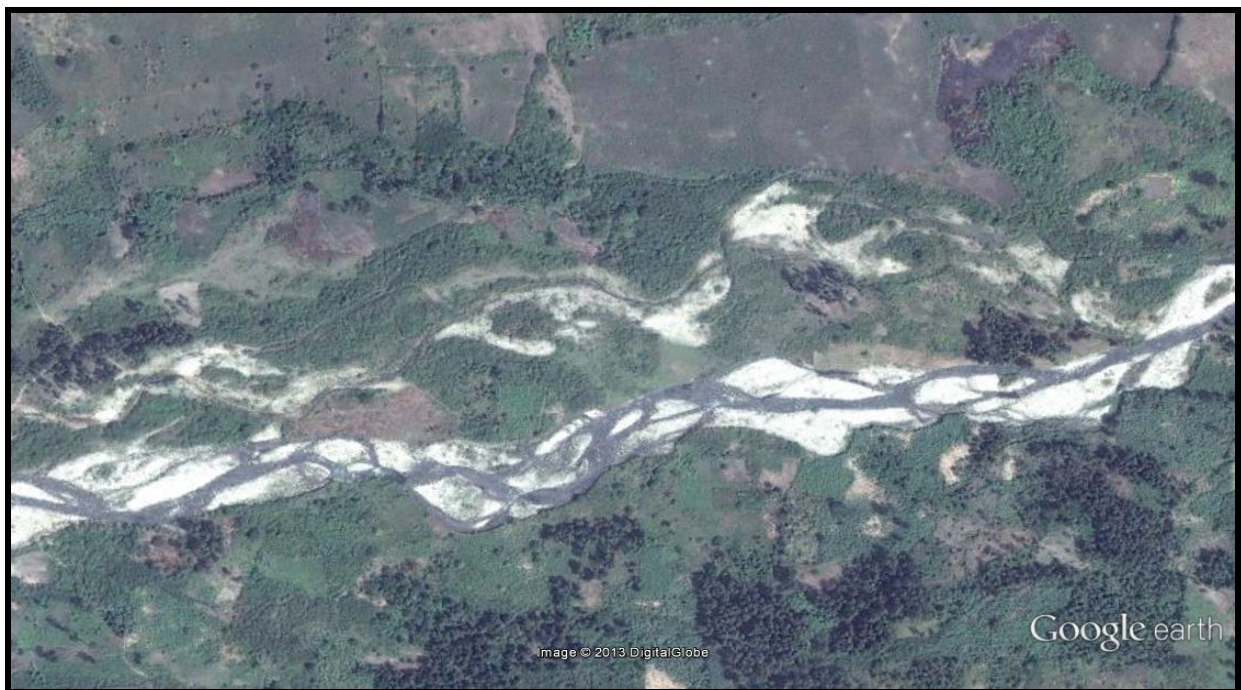
Figure 2.6: Channel migration in the Nyamwamba river. Source: Google earth image 2013

through channel avulsion. The channel migration zone (CMZ) is the outermost boundary that the river has historically used or will potentially use through bank erosion or avulsion into new channels. Although the CMZ is usually contained within the boundaries of the floodplain, in some cases the CMZ may extend outside of it. Where vegetation along the river has been removed, the erosion risk is generally greater. River Nyamwamba has an active river channel that moves over time (**Figure 2.6**). Houses that are built within or near the channel migration zone are at risk from flood damage, even if the flowing portion of the river is a substantial distance away. Over the past years, communities used to argue that flood damage could be reduced by increasing river channel conveyance by constant dredging and removal of other jam materials like digging out gravel so that the high flows could move unimpeded. However, these actions accelerate the erosive forces of the river and destabilize the river channel. The energy and erosive forces of high flows are actually slowed down by meanders, eroding banks, and the gravel load that the river transports. Location of structures must therefore be carefully done to avoid the potential risk of destruction by flood waters.

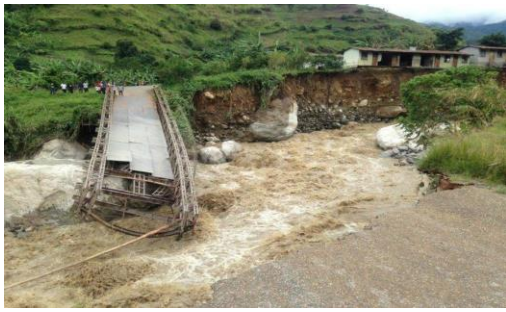
**Plate 2.4: Washed away bridge connecting to Kyanzuki and Kilembe SS (36N0166816 UTM0022310).
Photo credit: Kitutu Goretti**

The Kyarumba, Kilembe, Nyamwamba and Kithakena divisions lost all bridges (*plate 2.4 and plate 2.5*). River Mubuku also cut off one of the roads (*Plate 2.6*). In Kyarumba, Nyamwamba Division and Maliba roads were destroyed making it had for communities to access markets.

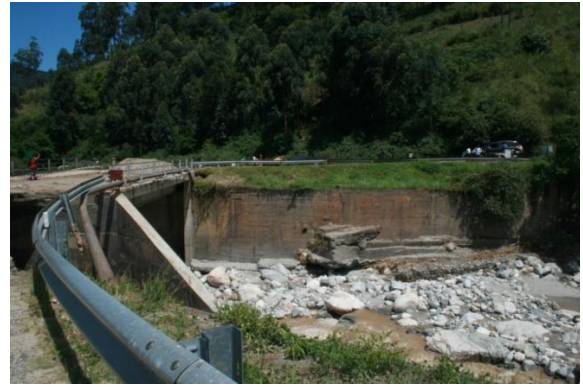
Plate 2.5: A bridge damaged at Kilembe town. Photo credit; Kitutu Goretti

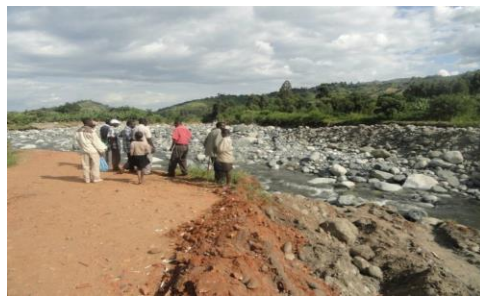
**Plate 2.6: River Mubuku destroyed the road and went back to the 1961 course.
Photo credit; Kitutu Goretti**

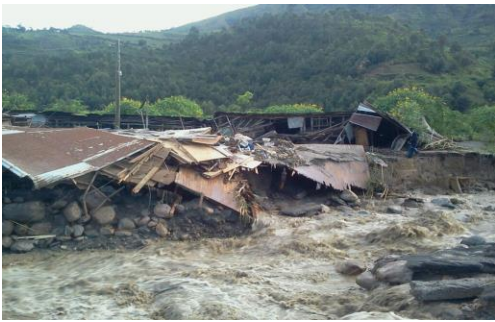
Plate: 2.7. Houses destroyed by floods in Kilembe

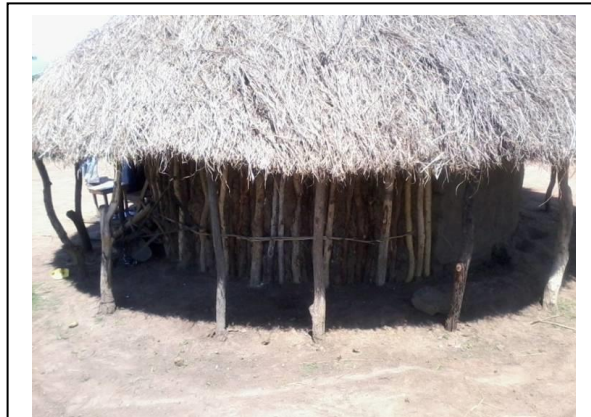
Plate 2.11. A house being renovated with poles after the wall was damaged by floods, 2013: Photocredit: Dr. Kitutu Goretti

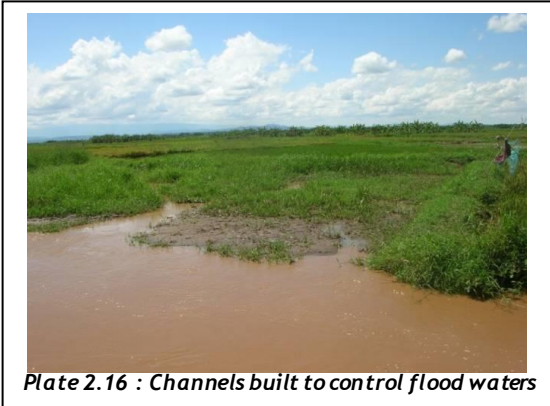
Plate 2.16 : Channels built to control flood waters

about the causes of floods in their area all mentioned the increased run-off from the Mount Elgon catchment. River Manafwa brings in a lot of silt which fills channels reducing the carrying capacity resulting into floods.

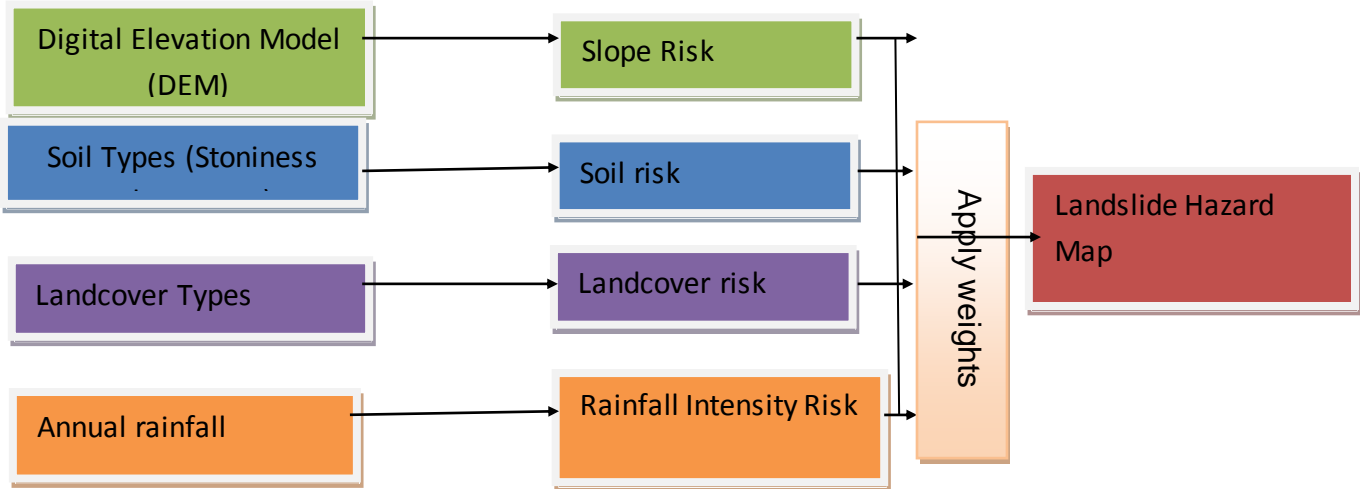
Figure 3.1 Landslide model for landslide assessment.

Landslides are common in mountainous areas. Mass wasting on the national scale was assessed by combining the following parameters in ArcGIS model builder;

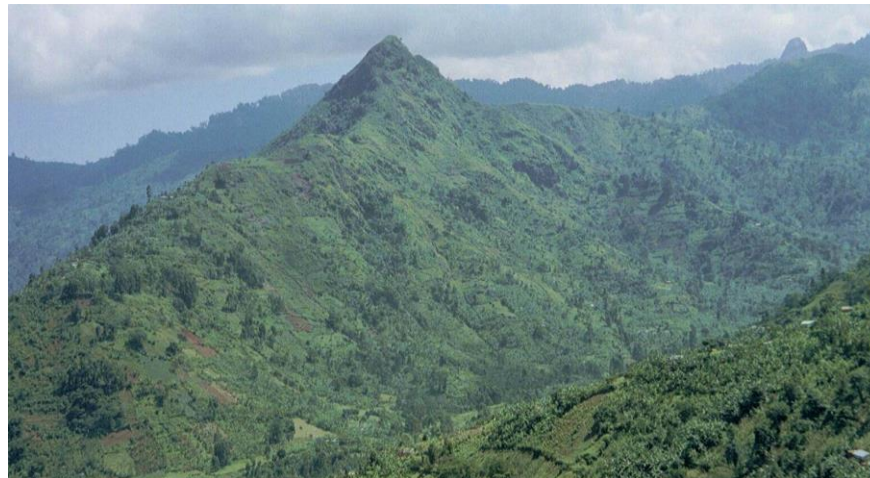
Plate 3.1: Nusu dyke one of the area with frequent landslides. Photo credit: Knapen 2009

The influence of vegetation is difficult to assess because almost no natural forest exists in Bududa. It is even difficult to know when the vegetation was cleared because it seems to be a long time ago. Despite this a few hills which had trees in the 1997 rainfall event did not suffer from landslides an indication that vegetation has a lot to play in preventing landslide occurrences (*Plate 3.1*).

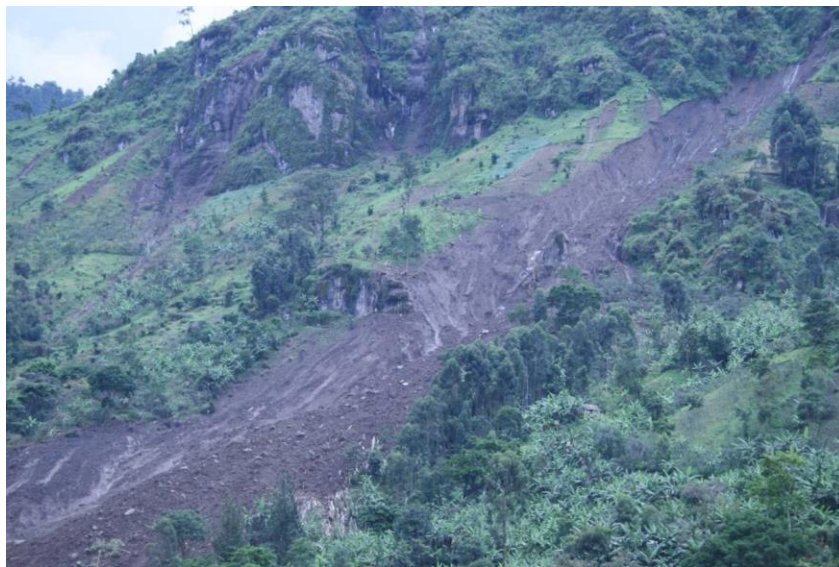
Nametsi landslide, 2010

Following continuous rains that started on the 25th February 2010 several soil slips occurred in Bududa. However, the most devastating was the debris flow that occurred on 1st March in Nametsi village killing about 365 people. These particular sites suffered from a landslide in 1997 and 4 people were killed. A huge boulder from this landslide in 1997 narrowly missed the Health Centre built by Care International but completely swept away in the 2010 debris flow. It was also reported that this site again suffered from a small landslides early this year with no damage. This could have been early warning signs for an impending major slope failure. The type of mass movement is a debris flow. Debris flows are one of the most dangerous of all mass wasting events. They can occur suddenly and inundate an entire village in a matter of minutes a case of what should have happened at Nametsi. Debris flows occur when masses of poorly sorted sediment, agitated and saturated with water, move down slopes.

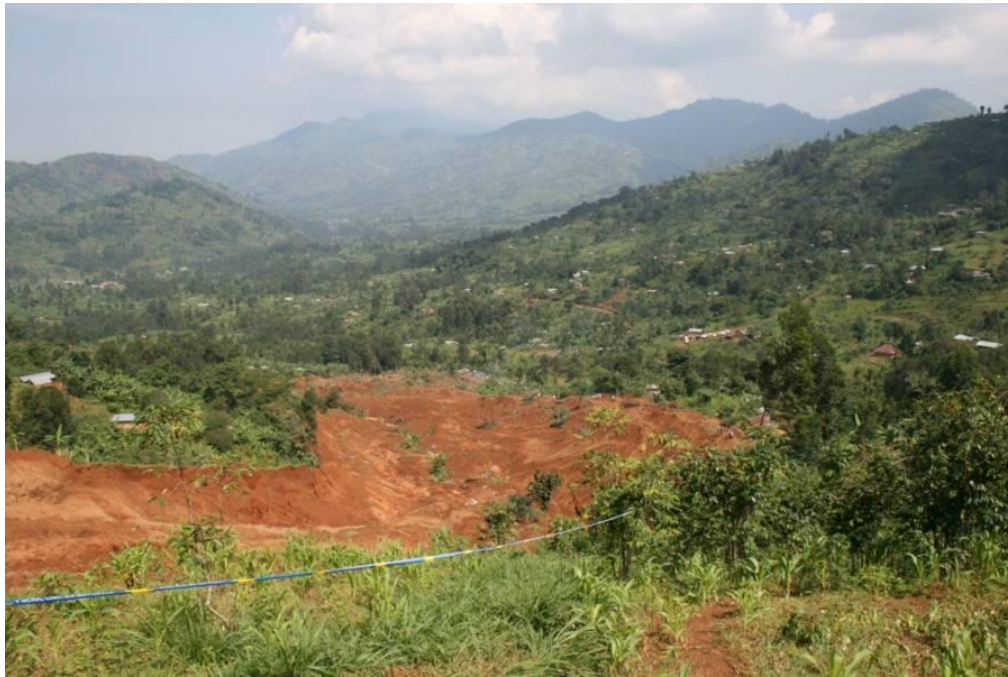
It was reported that it rained continuously for seven days and rain water infiltrated through a deep crack that formed on this slope in 2009. The water stagnated in the deep soil profiles causing water saturation and slope failure. The crack was as a result of movement of soil block because of water infiltration through the terraces and foot paths across the hill. The water that infiltrated through the cracks was trapped at the interface between the rock and soil which is known as saprolite (i.e. this occurred at an estimated depth of 15m). This water first moved the block of soil of about 300m in length including the trees and houses in the Northwest direction and later turned it in the southwest direction possibly following the flow of water underneath and deposited on a village about 500m downslope. So many questions have been asked why the eucalyptus forest could not stop the landslide. The reason is that the failure plane was deeper than the influence of the roots given that eucalyptus has shallow roots.

Bumwalukani landslide, 2012. Photo credit: Dr Kitutu Goretti

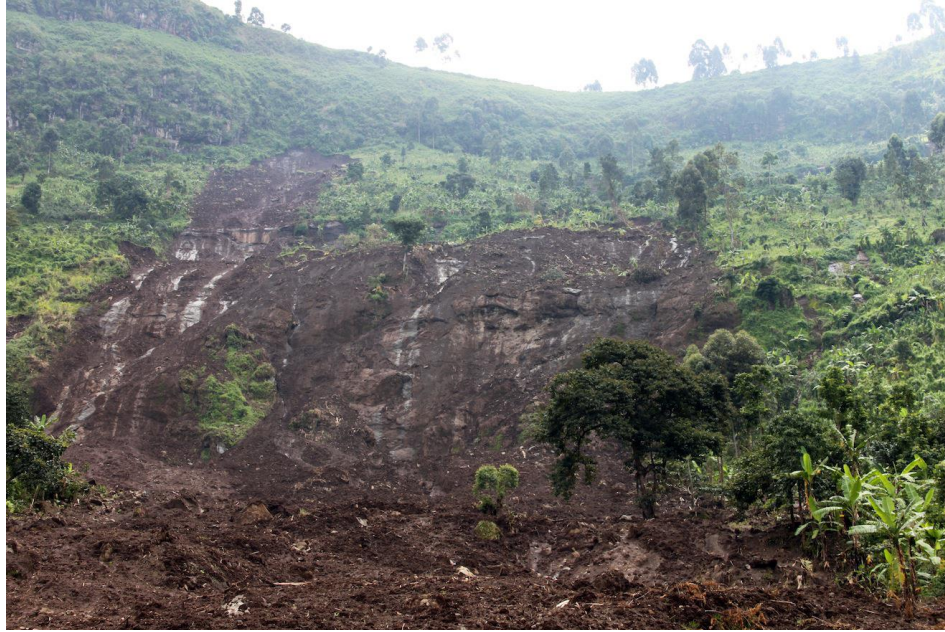
Plate. 3.3: A landslide in Bumasisifa which killed one elderly person in 2012.

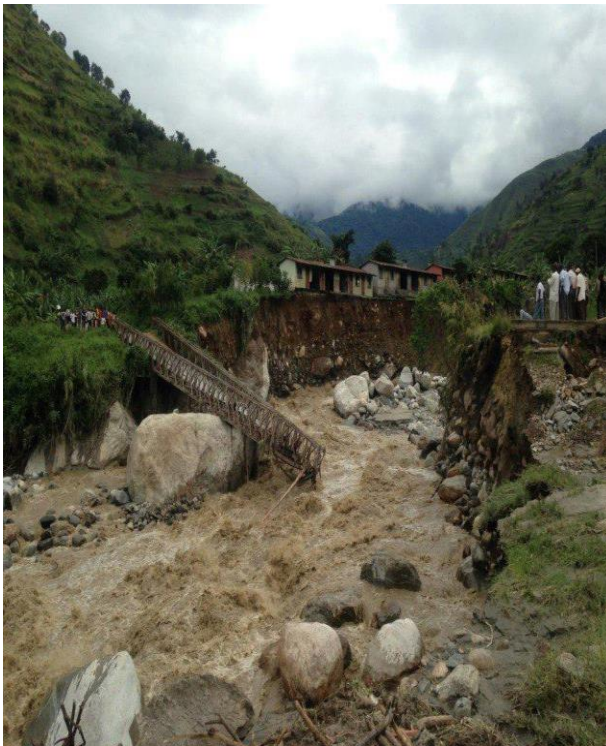
A broken bridge in Kilembe. Transport was greatly affected.

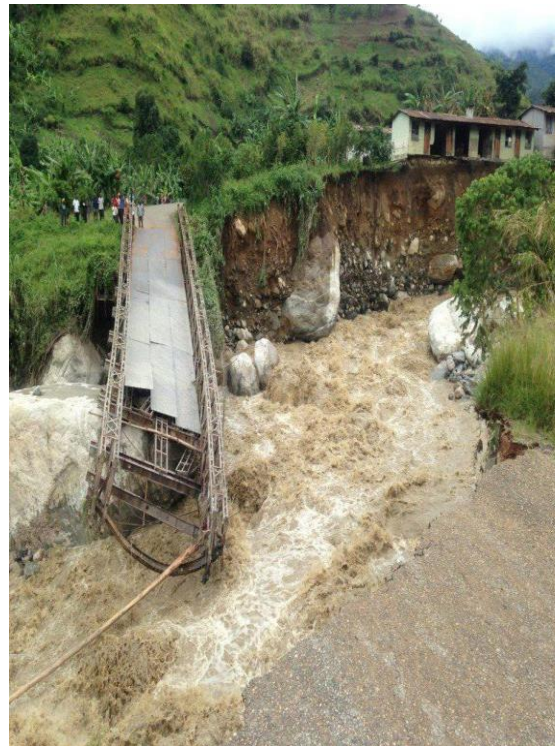
Houses hanging dangerously at the river bank in Kilembe after the floods.

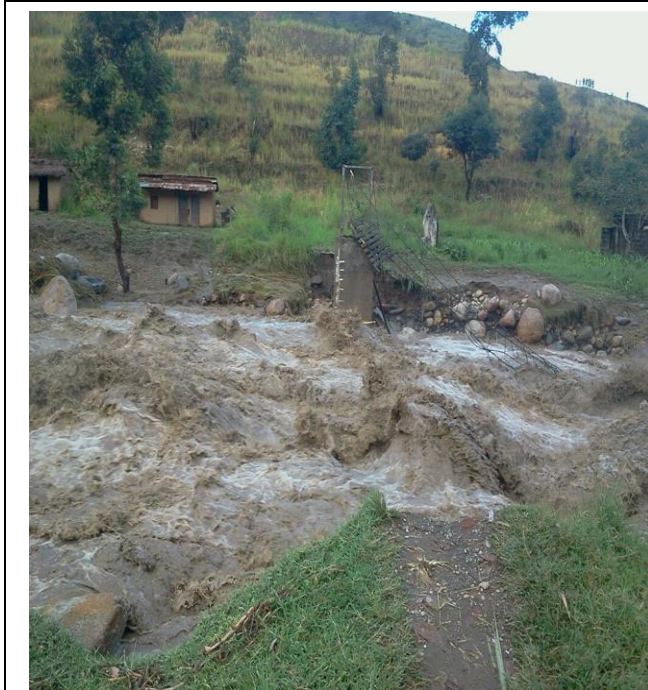
Broken bridge caused by too much water pressure and debris

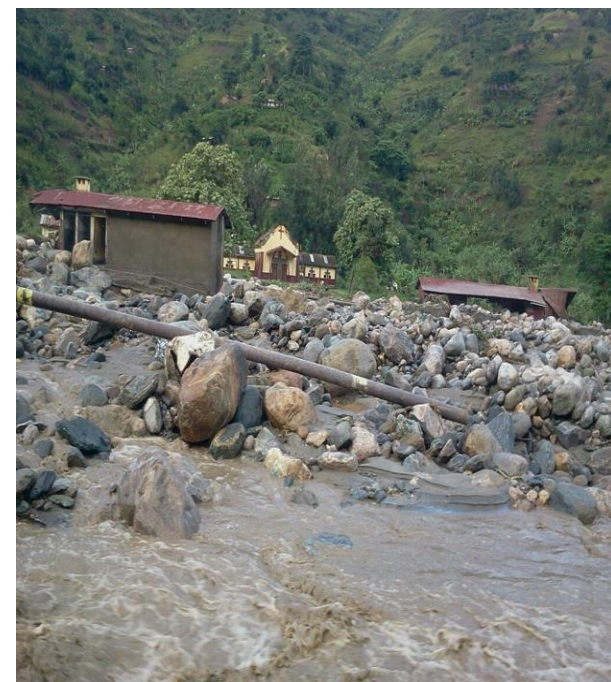
Broken pipes among debris brought by floods

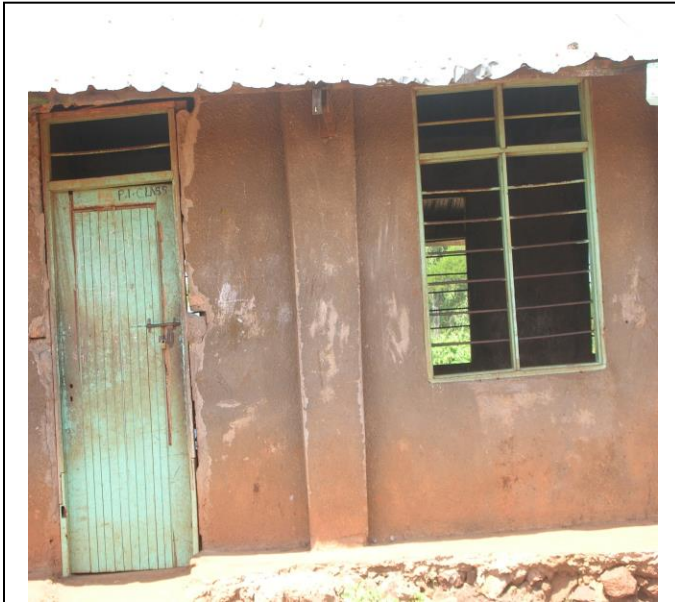
One of the building in Runyaya school that was struck by lightning
