### 3. LANDSLIDES IN UGANDA.

#### 3.1 Landslide hazard assessment.

## 3.2 Assessment of landslides in hotspots.

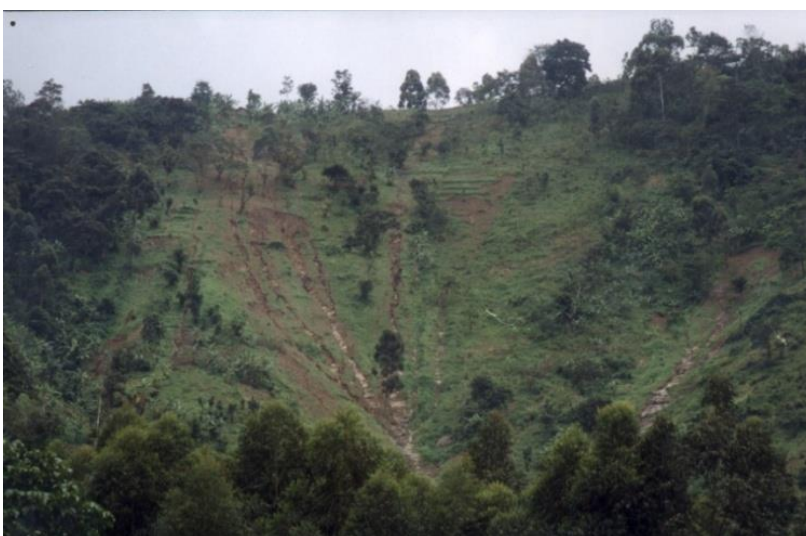
**Plate 3.2:** *Areas with vegetation had no landslides while bare areas had surficial slides in 1997.*

The influence of vegetation is difficult to assess because almost no natural forest exists in Bududa. It is even difficult to know when the vegetation was cleared because it seems to be a long time ago. Despite this a few hills which had trees in the 1997 rainfall event did not suffer from landslides an indication that vegetation has a lot to play in preventing landslide occurrences (*Plate 3.1 and Plate 3.2*).

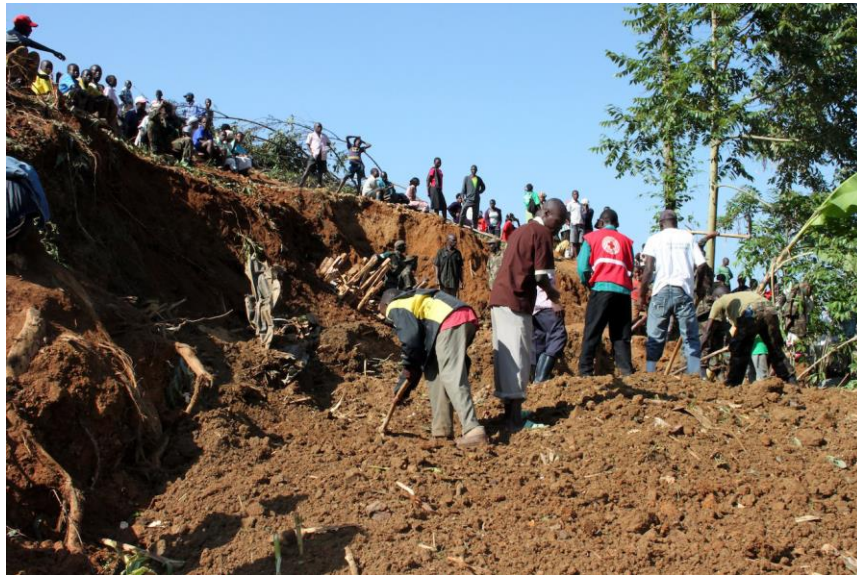
***Plate. 3.3: Communities searching for the dead in the Bumwalukani landslide, 2012. Photo credit; Dr. Kitutu Goretti***

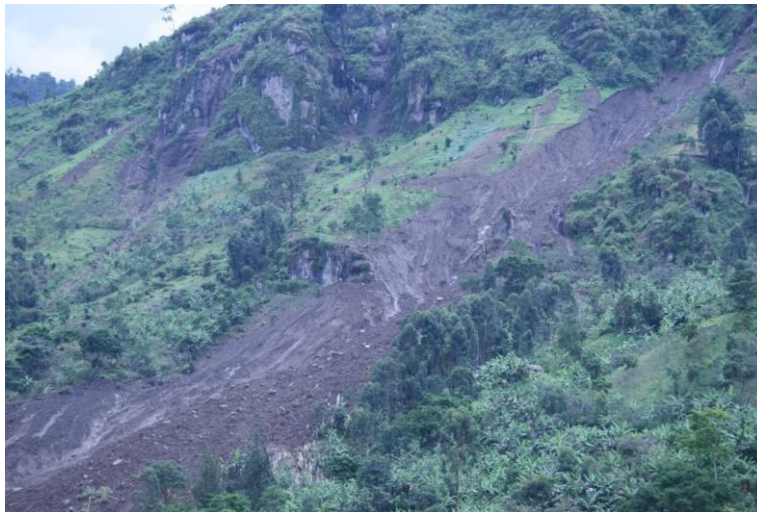
#### **Nametsi landslide, 2010**

*Following continuous rains that started on the 25<sup>th</sup> February 2010 several soil slips occurred in Bududa. However, the most devastating was the debris flow that occurred on 1<sup>st</sup> March in Nametsi village killing about 365 people. These particular sites suffered from a landslide in 1997 and 4 people were killed. A huge boulder from this landslide in 1997 narrowly missed the Health Centre built by Care International but completely swept away in the 2010 debris flow. It was also reported that this site again suffered from a small landslides early this year with no damage. This could have been early warning signs for an impending major slope failure. The type of mass movement is a debris flow. Debris flows are one of the most dangerous of all mass wasting events. They can occur suddenly and inundate an entire village in a matter of minutes a case of what should have happened at Nametsi. Debris flows occur when masses of poorly sorted sediment, agitated and saturated with water, move down slopes.*

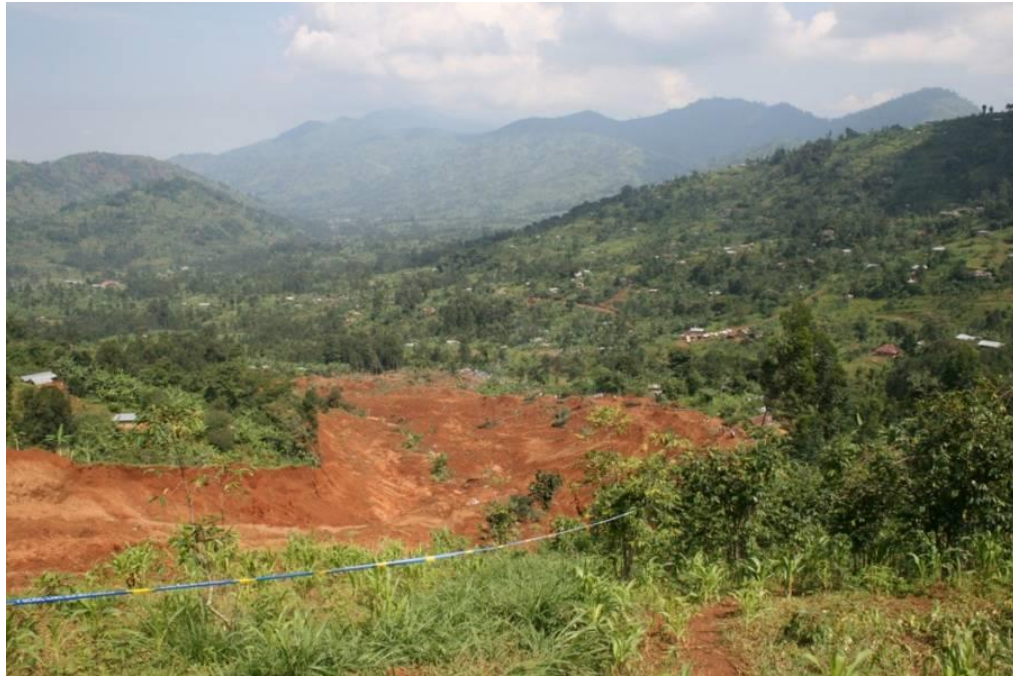
*On 25<sup>th</sup> June 2012 at 2.00pm a landslide occurred at Bumwalukani in Bududa district destroying two villages. Plate. 3.2 shows communities searching for the dead in the Bumwalukani landslide, 2012. About 25 houses were destroyed and 8 people killed. The length of the landslide was 540m, the average width was 130m and the depth of the scar was about 15m. The depletion zone was about 300m of long and the deposition zone was about 240m. The volume of soil displaced was about 700,000m<sup>3</sup> which qualifies it to be a huge landslide. The upper slope of the landslide is about 40° and the lower slope 20°. The type of landslide is an earth slide.*

*It was reported that it rained continuously for seven days and rain water infiltrated through a deep crack that formed on this slope in 2009. The water stagnated in the deep soil profiles causing water saturation and slope failure. The crack was as a result of movement of soil block because of water infiltration through the terraces and foot paths across the hill. The water that infiltrated through the cracks was trapped at the interface between the rock and soil which is known as saprolite (i.e. this occurred at an estimated depth of 15m). This water first moved the block of soil of about 300m in length including the trees and houses in the Northwest direction and later turned it in the southwest direction possibly following the flow of water underneath and deposited on a village about 500m downslope. So many questions have been asked why the eucalyptus forest could not stop the landslide. The reason is that the failure plane was deeper than the influence of the roots given that eucalyptus has shallow roots.*

*Bumwalukani landslide, 2012. Photo credit: Dr Kitutu Goretti*

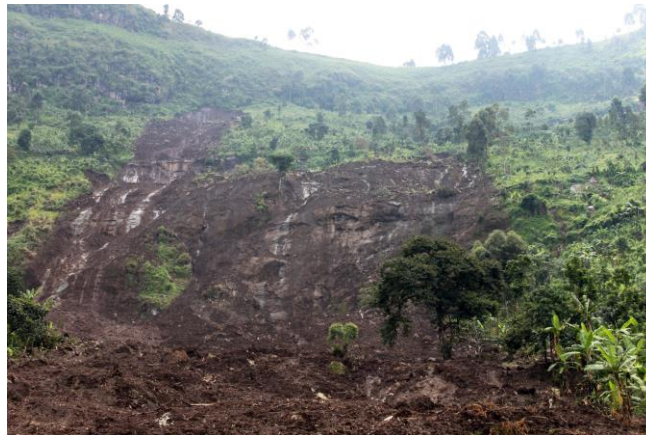
**Plate. 3.4: A landslide in Bumasifa which killed one elderly person in 2012.**

Many sub counties in Sironko and Bulambuli recognize landslides as a major social problem and they have been integrated in their Sub-county Development plans. However, mitigation measures put in place are on individual basis and they are inadequate. Neither the sub-county nor the district local governments have made any effort to mitigate the landslide problem. High population pressure, over-cultivation and deforestation were seen as drivers to landslide occurrence and they are more common on cultivated land. Based on indigenous knowledge, the local population can tell with a high degree of certainty using early warning signs the landslide prone areas. However, very few respond to such warnings because of the costs involved. As an intervention some sub-counties were aided in 2001 through a Germany funded project to begin tree seedling banks for farmers but this has been abandoned since the project ended. Plate. 3.3 shows a landslide in Bumasifa which killed one elderly person in 2012.

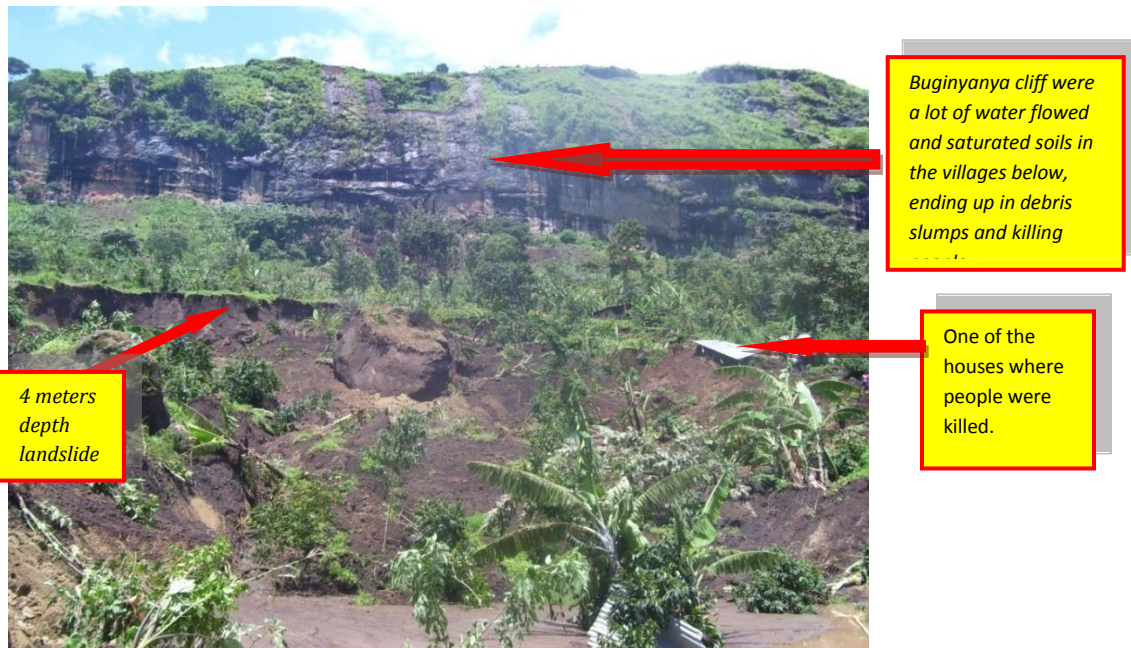
Photo credit: Dr. Kitutu Goretti, 2011

*On the night of 29<sup>th</sup> to 30<sup>th</sup> August 2011 landslides devastated the parts of Sisiyi and Buluganya killing 26 people. Mabono Parish in Sisiyi sub-county was most affected with over 10 landslides of which three were disastrous. The other sub-county affected was Buluganya where surface water flow from the Butandiga ridge caused many slips. Most of the landslides in Mabono parish were caused by high run-off from the steep cliffs however the most disastrous landslide was a translational slide that ended up in a mild flow. This landslide killed 16 people and was triggered by heavy water flow from the agglomerate cliff in Buginyanya. This water saturated the B horizon of the soils below the cliff that is rich in clay causing the soil block to move for about 300m before it was deposited on the lower area where there were houses. One of the survivors from this landslide narrated her ordeal and how she survived narrowly. It was reported that it rained continuously for about eighteen hours. The length of the landslide was 500m, the depth of the scar was 4m and the volume of debris displaced was 400,000 cubic meters. The main impacts of these landslides are loss of life, loss of farmlands, damage to property, roads and bridges.*
